# **PDAS Appendix I – Arboricultural Impact Assessment**

## Arboricultural Impact Assessment Axis PED

### Grove Farm

Date: November 2023

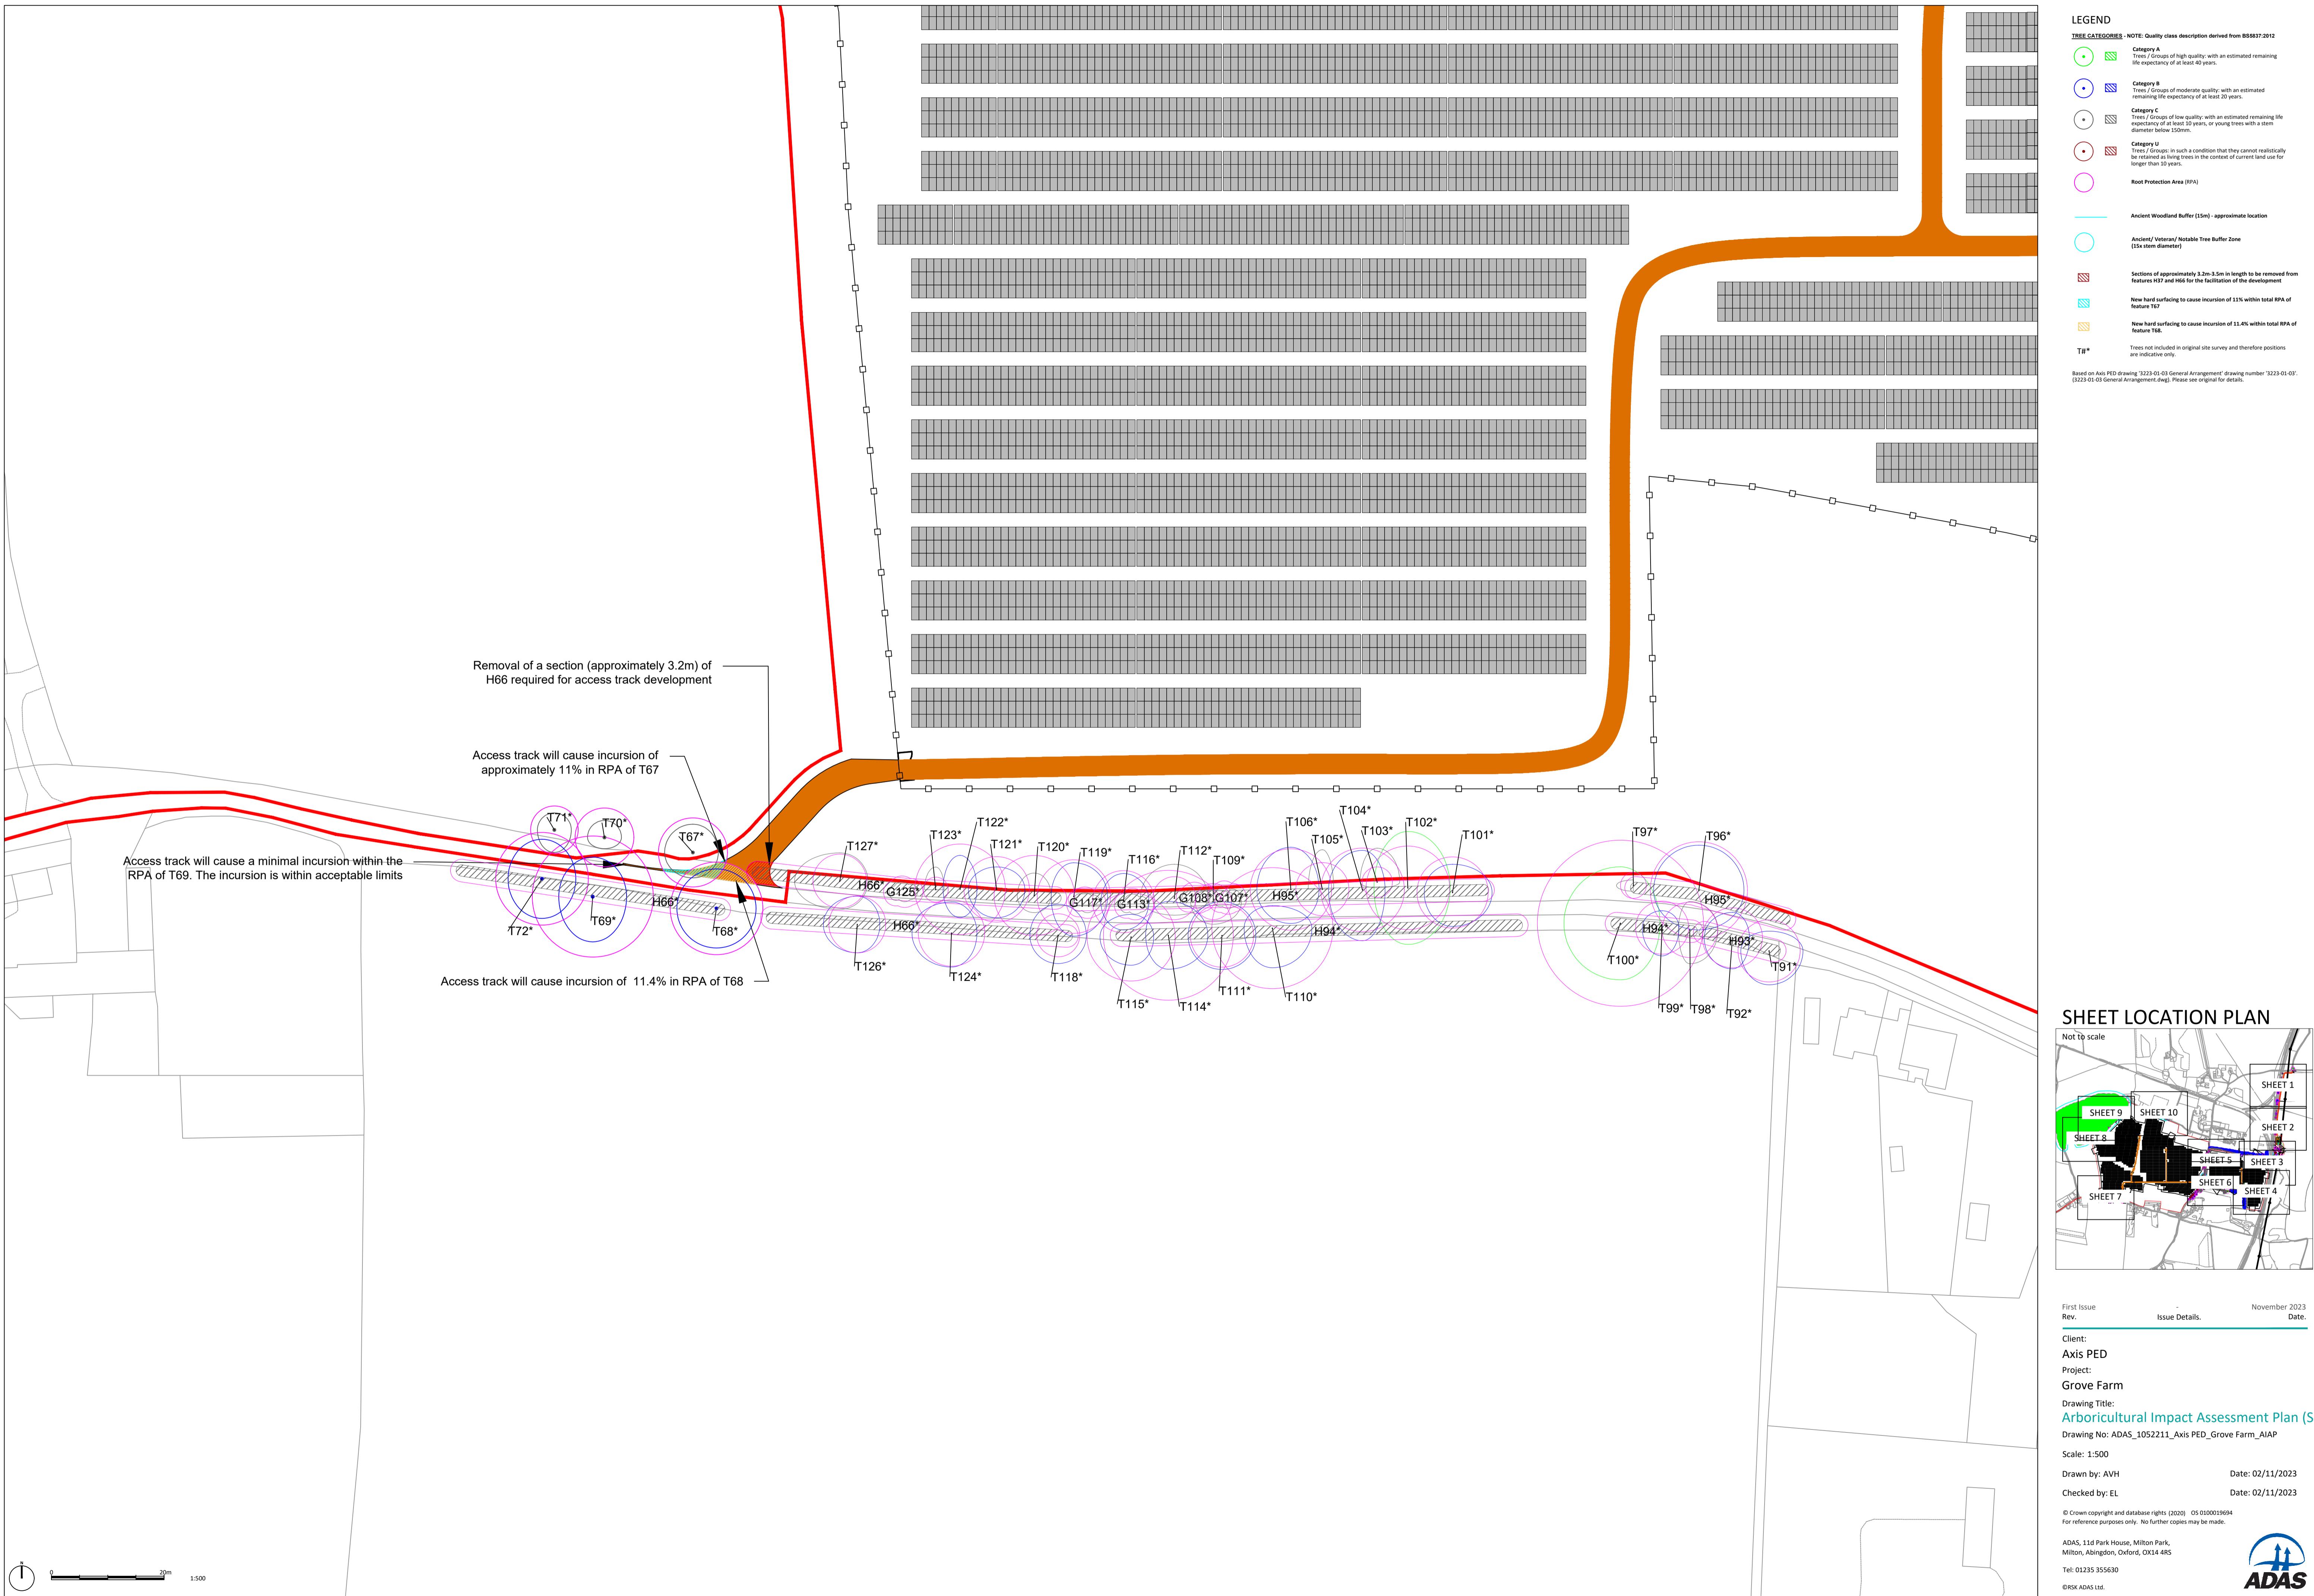
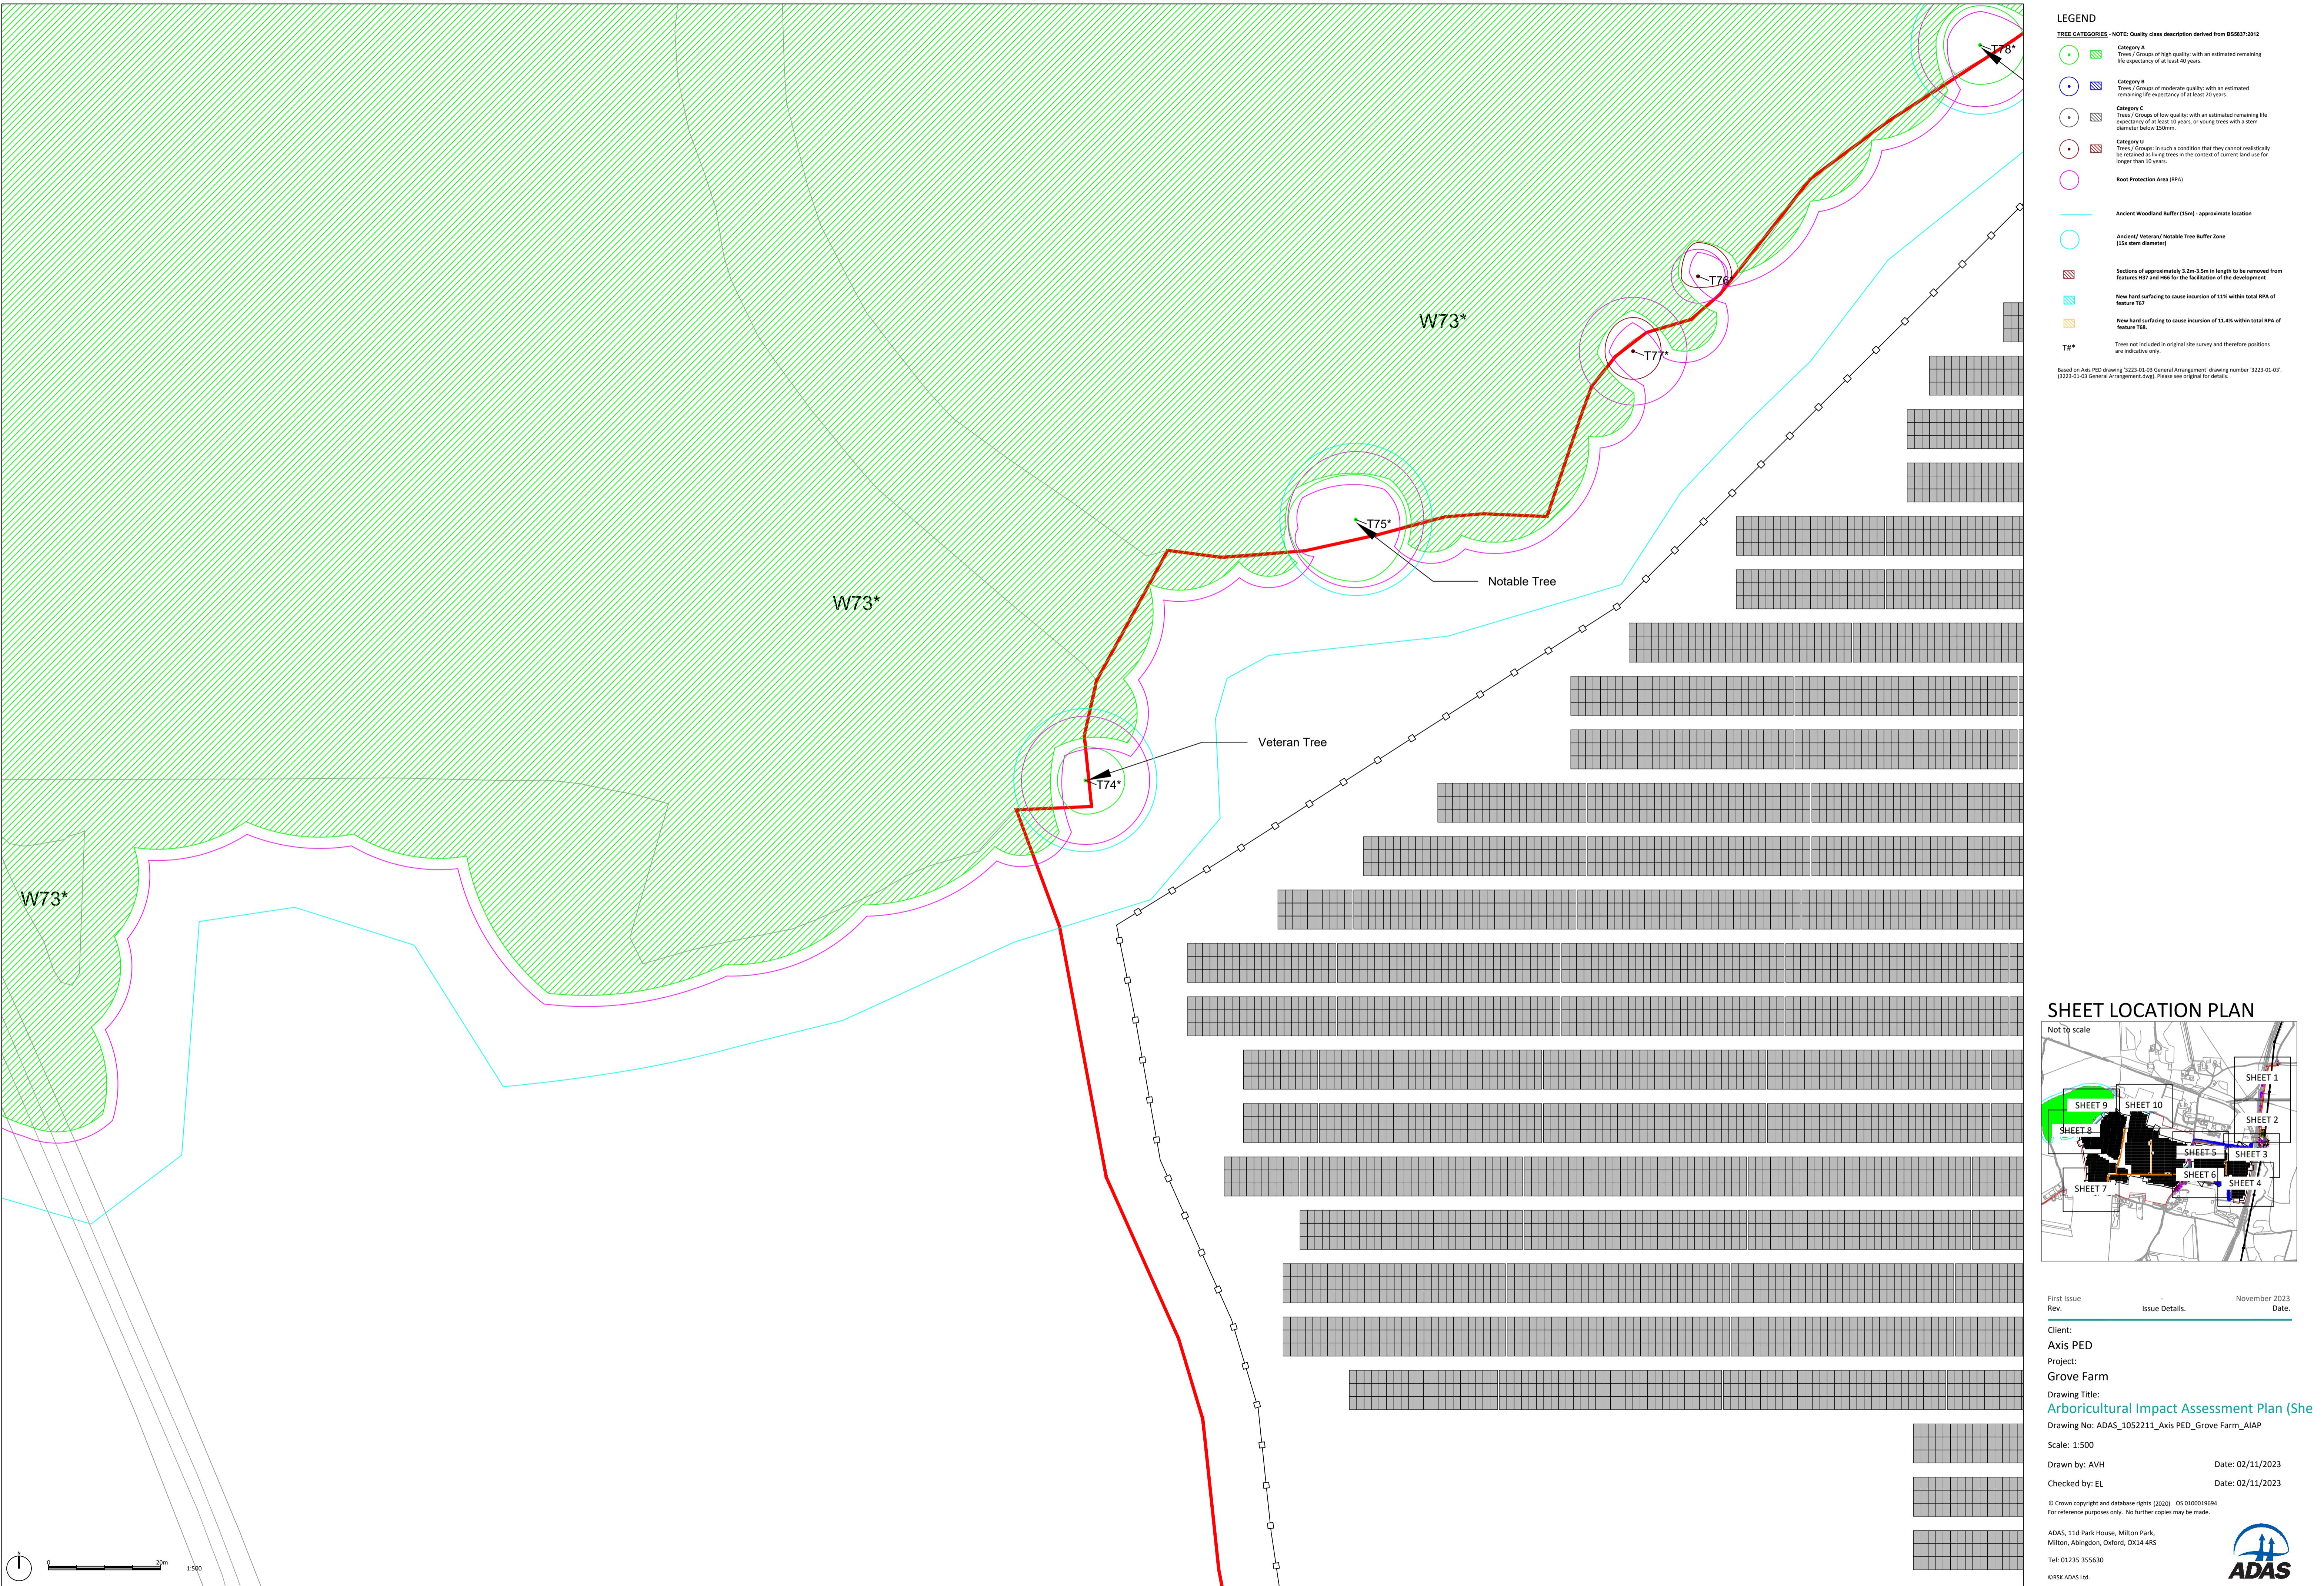
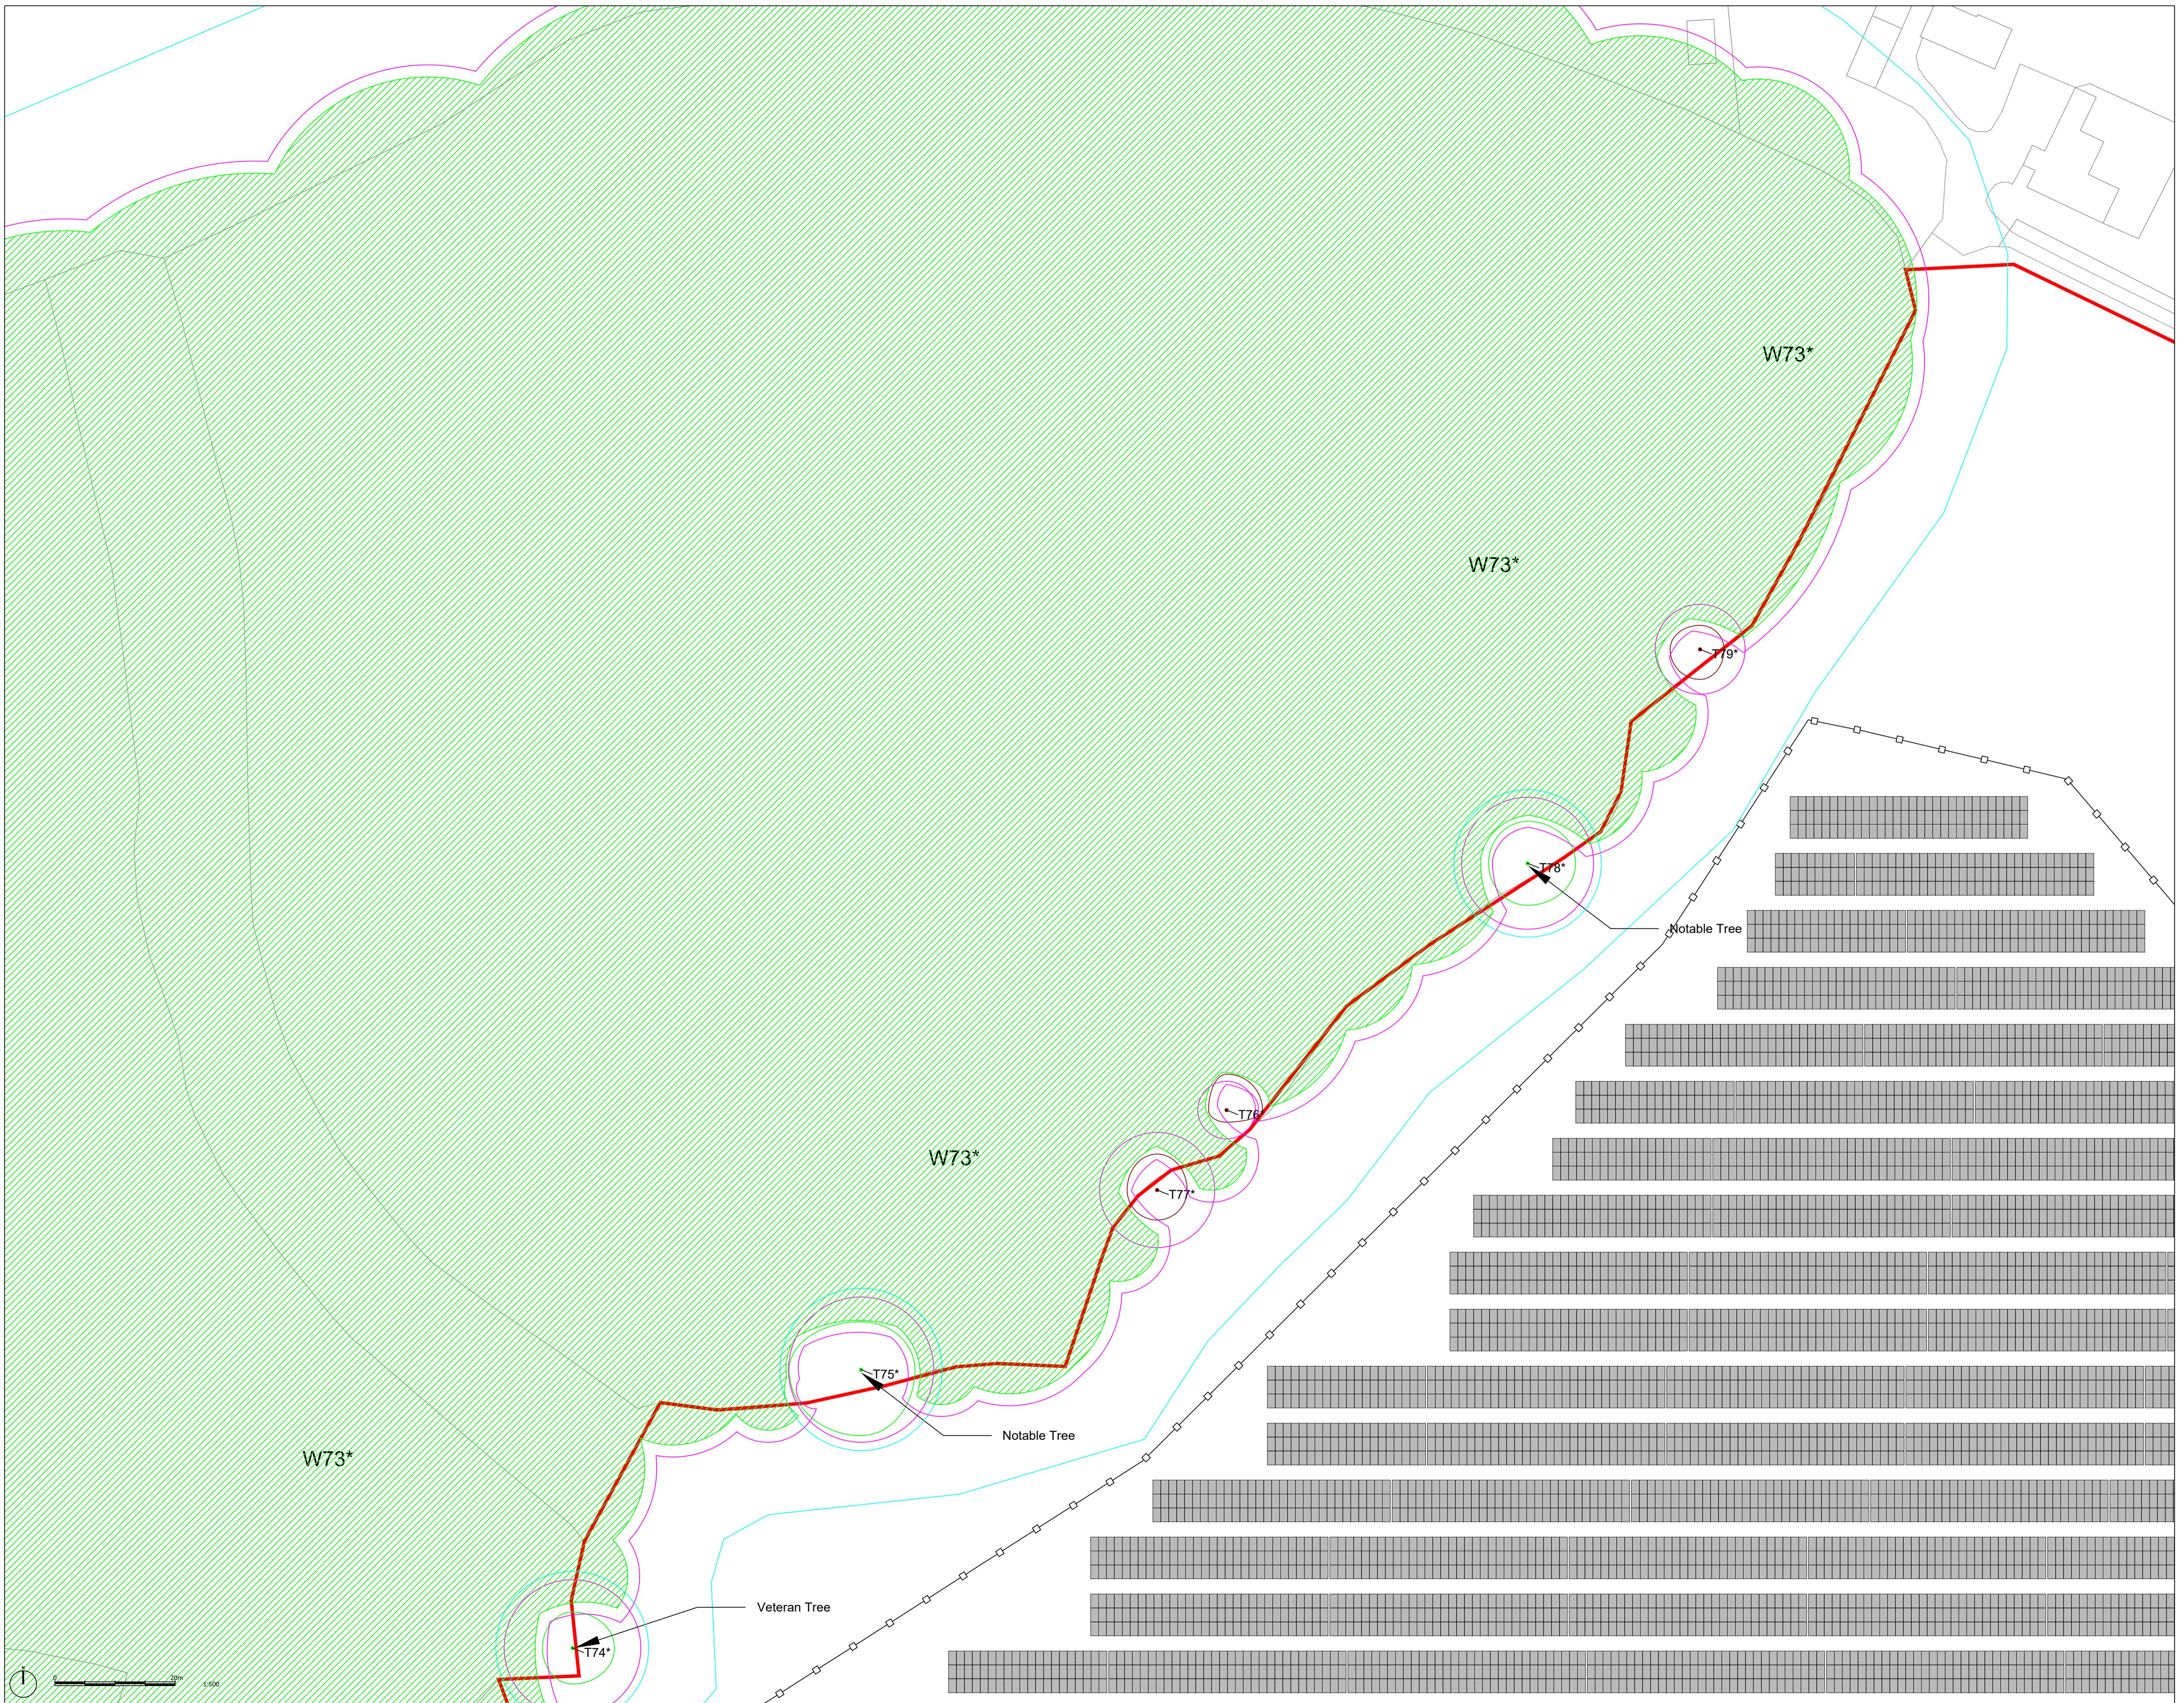
**New hard surfacing to cause incursion of 11% within total RPA of feature T67**

**New hard surfacing to cause incursion of 11.4% within total RPA of feature T68**
