Babergh District Council
Bentley Conservation Area Appraisal and Management Plan
November 2025

Bentley Conservation Area Appraisal and Management Plan

November 2025

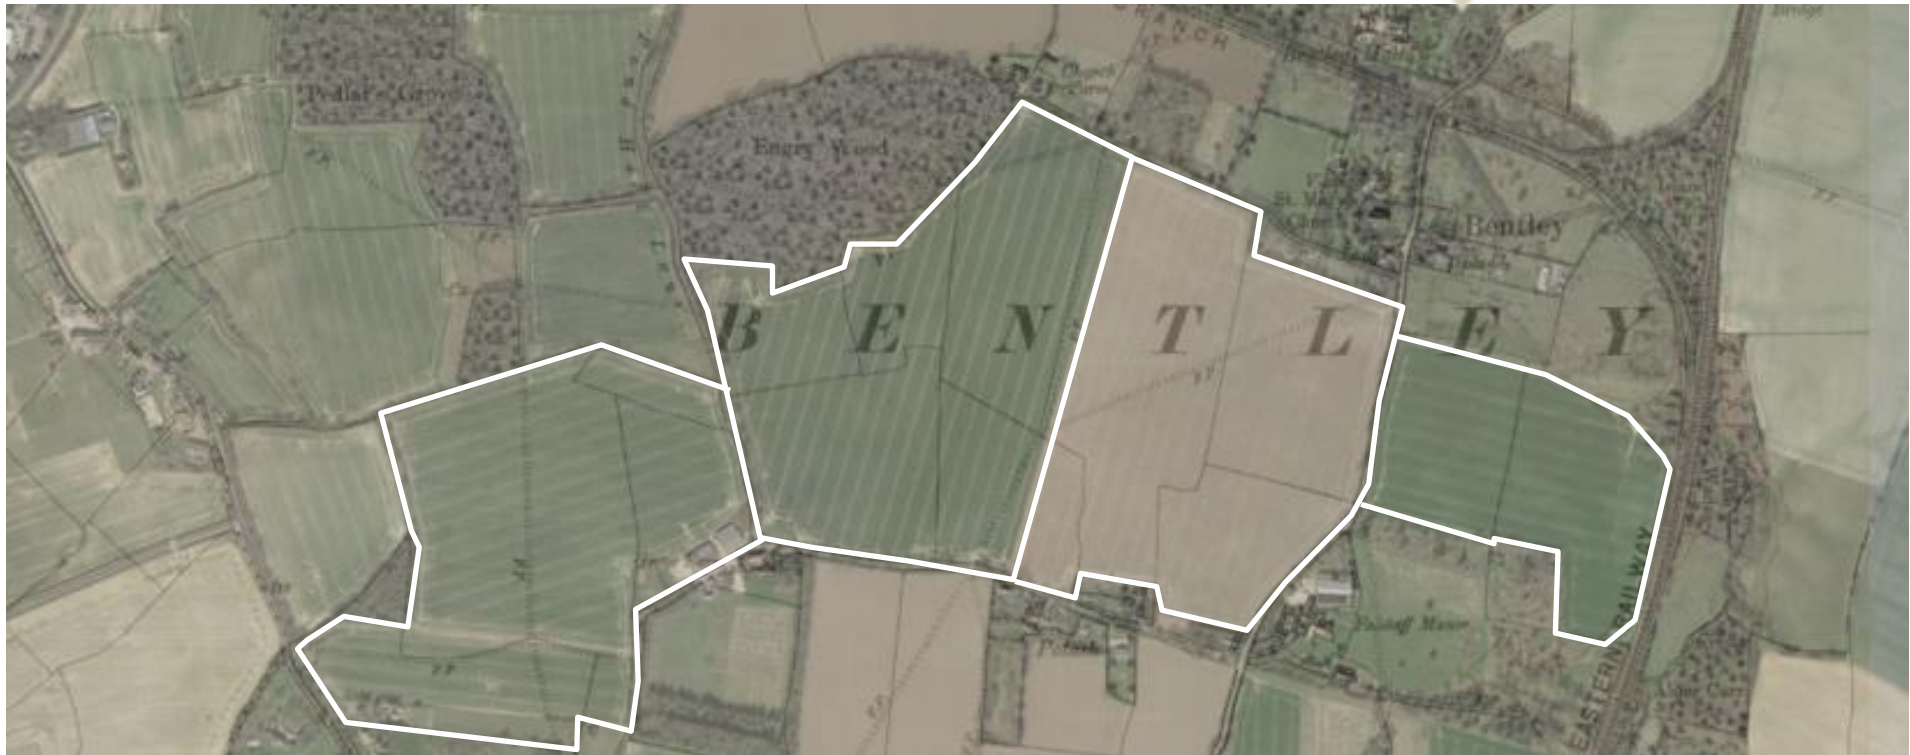
figure 18: Field patterns – land north of Potash Lane – Contemporary aerial photograph overlaid with 1883 Tithe Map [much of the underpinning structure remains intact]

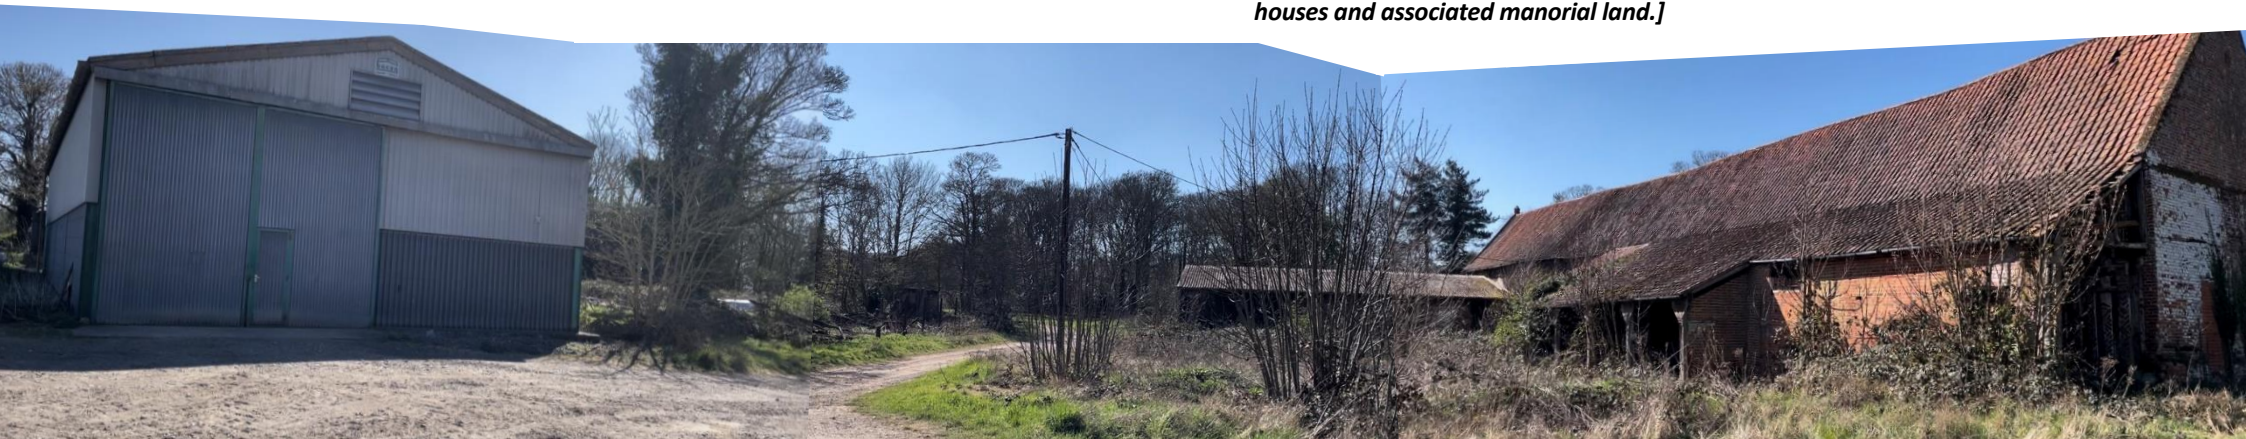
figure 92: An unfortunate juxtaposition. Modern industrial style agricultural metal shed adjacent to the Grade I listed, 'Elizabethan' Bentley Hall Barn. Whilst both may be said to have an agricultural provenance, the modern interloper harms the setting of the magnificent and historically important 'Elizabethan' barn.

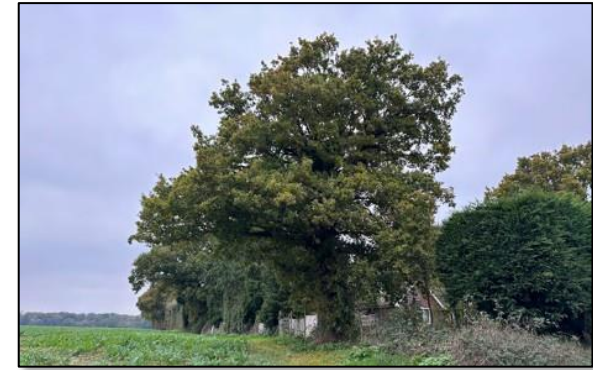
figure 107:
Run down and dilapidated fencing along the southern side of Little Bush, south of St Mary's Church would benefit from sensitive repair or replacement.

Boundary treatments on the whole have a rustic and modest appearance. Where they have not been successful is where modern, tall, close boarded fencing, or industrial metal palisade fencing have been introduced. The former restricts views into the grounds having a negative impact on views, the latter introduces an incongruous industrial feature into the area. Both would benefit from removal for more sensitive open boarded fencing where possible. Similarly, a number of signposts have been erected in the area with a metal mass manufactured appearance and would benefit from replacement with bespoke timber units, which would be more complementary to a rural nature of the area.

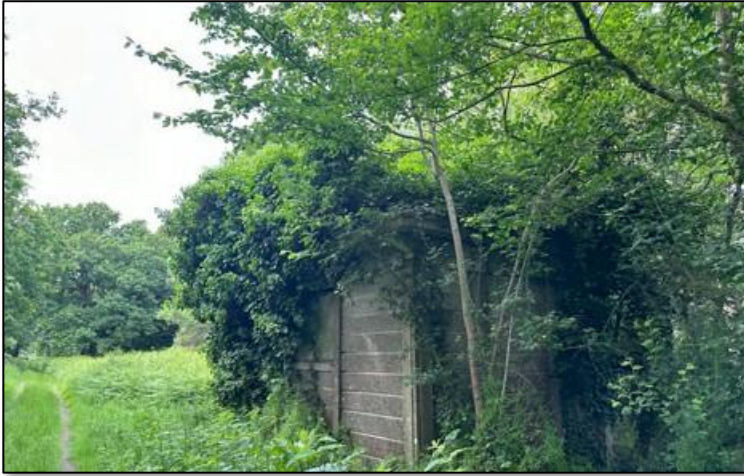
figure 108:
Former railway platelayer hut in a poor state of repair.

There are a few other structures in the area that have been neglected including the platelayer hut along the former Bentley-Hadleigh branch line and outbuilding close to Pond Hall. With regards to the former, this would benefit from repair and potentially information boards which would better reveal its significance. With the latter this would benefit from either demolition or repair/replacement.

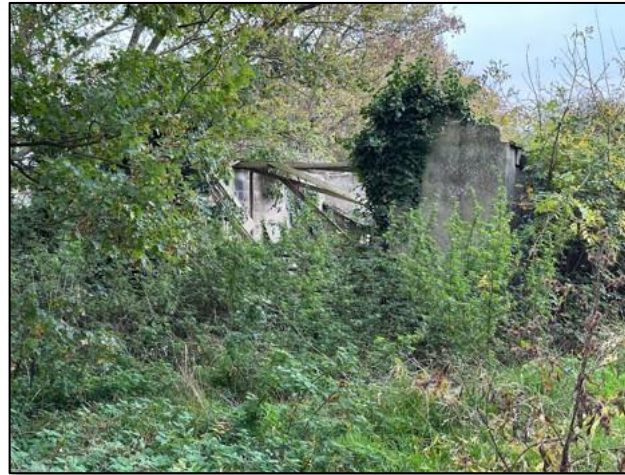
figure 109:
There are a number of scattered dilapidated buildings across the conservation area that would benefit from repair restoration or removal (here to the south-west of Pond Hall).

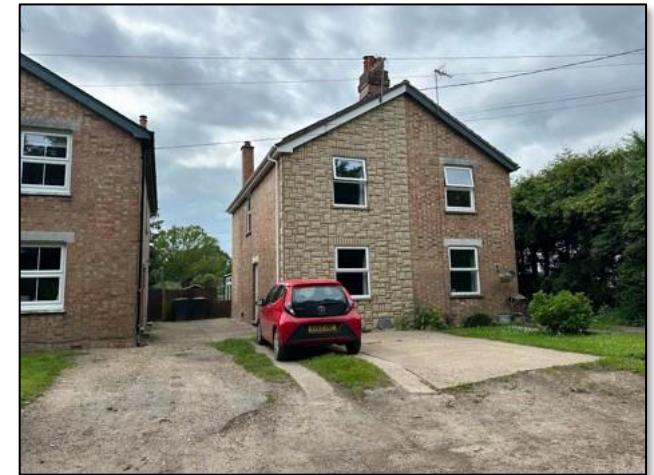
figure 110:
Inappropriate stone cladding to Falstaff Cottages [pre-dates conservation area]

In relation to point 3, there are a surprisingly limited number of buildings that have been insensitively adapted, with many featuring their original details or appropriate modern interventions. Some properties along Potash Lane have had their original fenestration details altered and replaced with unsympathetic uPVC units. The reintroduction of appropriate timber windows and original fenestration would have a beneficial impact on the building and in turn the wider conservation area. Similarly, one of the Falstaff cottages has had its facade replaced with stone external wall cladding. Stone is not found in modest domestic buildings in the conservation area, and it has unbalanced the symmetry of the original building. Its removal, subject to the condition of the bricks beneath, would provide a beneficial impact to both the building and the conservation area. Historic photographs can also be a helpful source of information when deciding on what details are appropriate to reinstate (appendix 4).

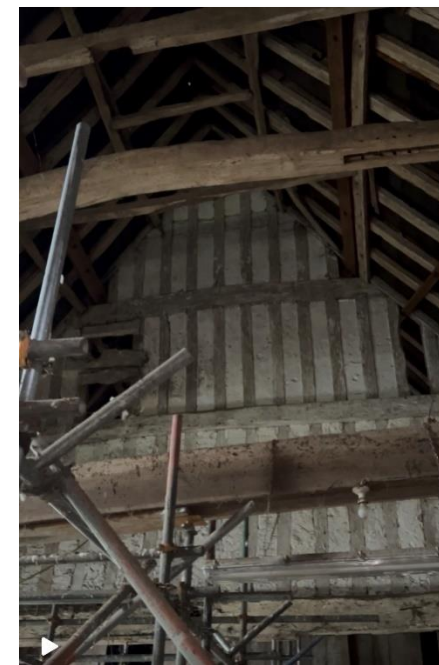
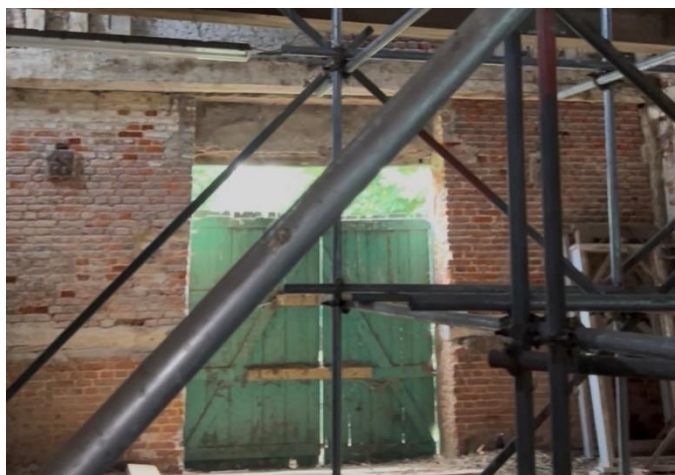
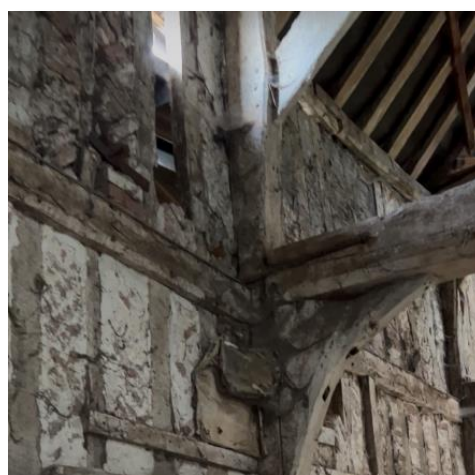
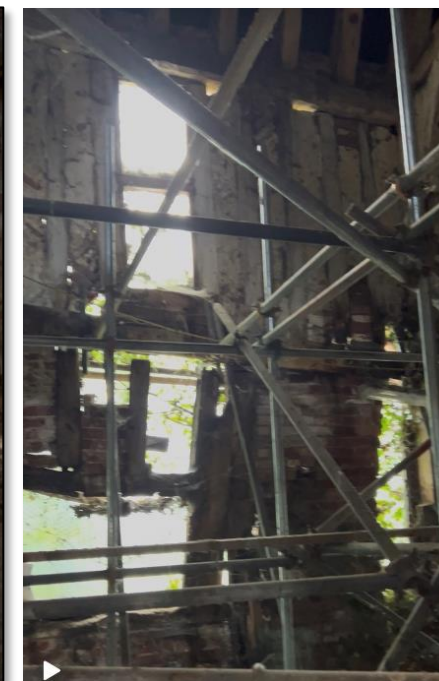
figures 126: Bentley Hall Barn Interior [2025]

In relation to point 2, the most noticeable derelict building in the area is the grade I listed Bentley Hall Barn. This building is of the highest significance and is on Historic England's At Risk Register. It is imperative that a sensitive use is adopted for the building to ensure its future survival and optimum viable use. The removal of modern elements attached to the building and some limited development based on former historic structures to the east of the barn (seen on the historic mapping and historic photograph in appendix 4) would provide a helpful framework for future development.

The most noticeable building in need of restoration in the Conservation Area, is Bentley Hall Barn, which is a Grade I listed Elizabethan barn. It is a priority that the building is repaired and restored as it has been empty for a number of years and its condition has deteriorated. The current owner has taken steps to try and keep the building weather and watertight, but the work undertaken is only providing temporary protection and the buildings itself is vulnerable for a number of reasons. The future wellbeing of this important heritage asset needs to be secured, and the Council will encourage the owner to consider appropriate re-use of the building.

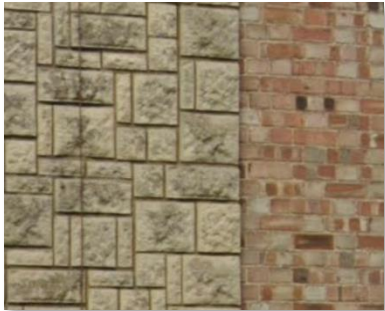
figure 127:
Example of inappropriate cladding in what is now conservation area.

In relation to point 3, there are a surprisingly limited number of buildings that have been insensitively adapted, with many featuring their original details or appropriate modern interventions. Some properties along Potash Lane have had their original fenestration details altered and replaced with unsympathetic uPVC units. The reintroduction of appropriate timber windows and original fenestration would have a beneficial impact on the building and in turn the wider conservation area. Similarly, one of the Falstaff cottages has had its facade replaced with stone external wall cladding. Stone is not found in modest domestic buildings in the conservation area, and it has unbalanced the symmetry of the original building. Its removal, subject to the condition of the bricks beneath, would provide a beneficial impact to both the building and the conservation area. Historic photographs can also be a helpful source of information when deciding on what details are appropriate to reinstate (appendix 4).

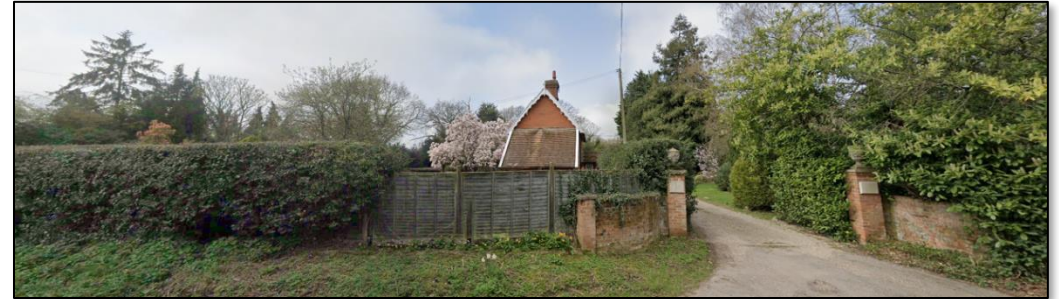
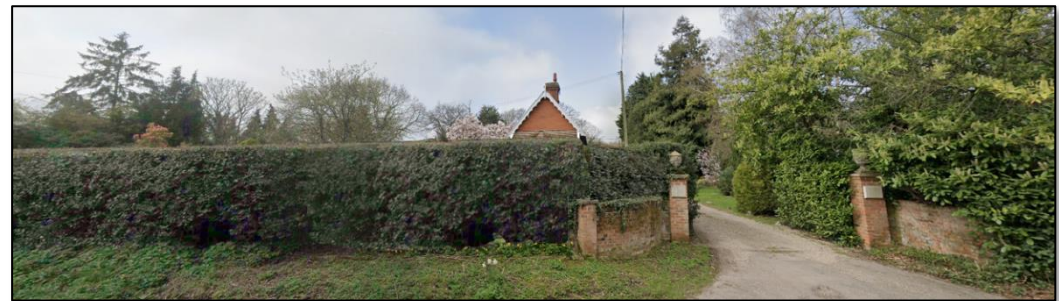
figures 128:
Example of how character and appearance might be enhanced [mock-up image] Cottage adjacent to St. Mary's Church

Boundary treatments on the whole have a rustic and modest appearance. Where they have not been successful is where modern, tall, close boarded fencing, or industrial metal palisade fencing have been introduced. The former restricts views into the grounds having a negative impact on views, the latter introduces an incongruous industrial feature into the area. Both would benefit from removal for more sensitive open boarded fencing where possible. Similarly, a number of signposts have been erected in the area with a metal mass manufactured appearance and would benefit from replacement with bespoke timber units, which would be more complementary to a rural nature of the area.
